Manhole Inspection Summary

Manhole # S45CC_025MH

Insp Date: 11/21/08 11:33 AM

Location Address: **rear 1811 chase st**

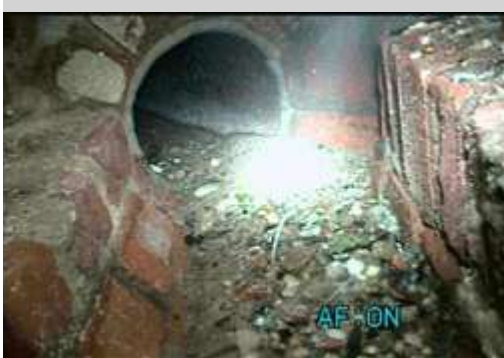
Defect 4

Condition: ☐ Sound ☐ Cracked ☐ Root Intrusion ☐ Deteriorated ☐ Leaks ☒ **Debris**

channel debris

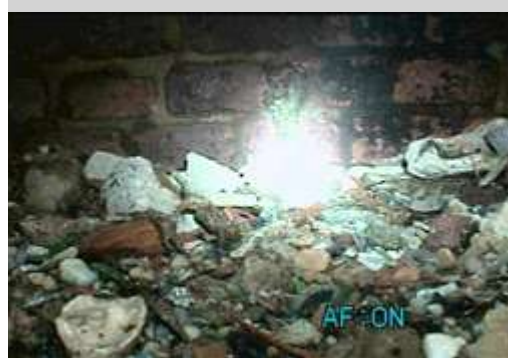
Defect 3

Condition: ☐ Sound ☐ Cracked ☐ Root Intrusion ☐ Deteriorated ☐ Leaks ☒ **Debris**

bench debris

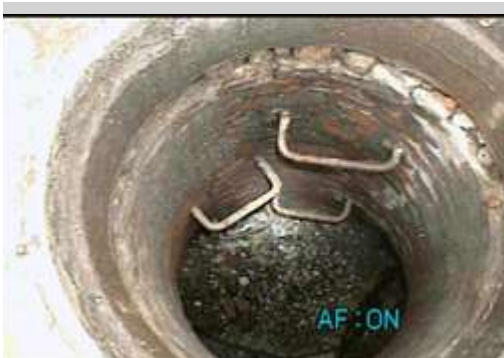
Defect 2

Steps Count: **4** Missing: **0** ☒ **Corroded**

corr steps

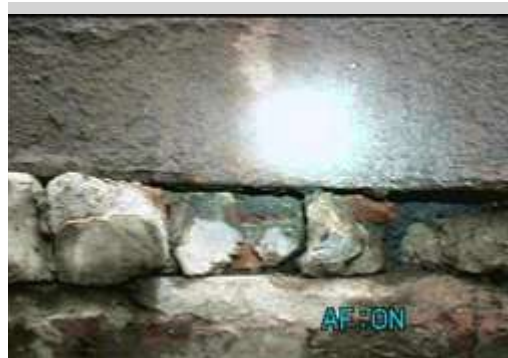
Defect 1

Condition: ☐ Sound ☒ **Cracked** ☐ Root Intrusion ☒ **Loose Brick** ☒ **Deteriorated**

chimney loose bricks
